**Flood Control Project Maintenance  
Levee Inspections**

**Fall 2012 Levee Maintenance Deficiency Summary Report**

**Reclamation District No. 0755 Randall**

**Levee Inspection Report By Mile - Fall 2012**

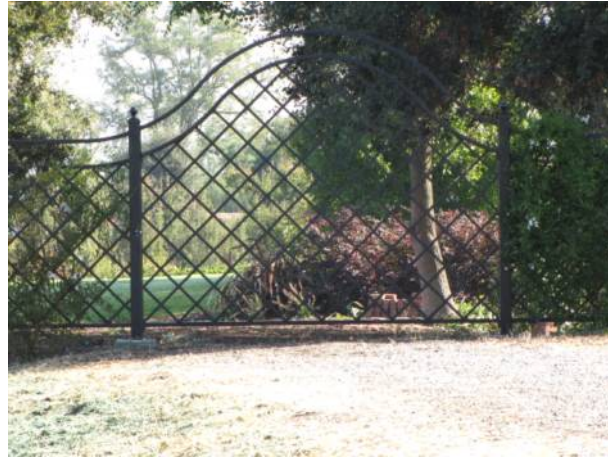
Levee Mile Report Line	4
Start Levee Mile	0.02
End Levee Mile	0.02
Location	Land Side
Category	Earthen Levee
Item	Encroachments

This is the gate Mr. Hemley has installed without a permit.

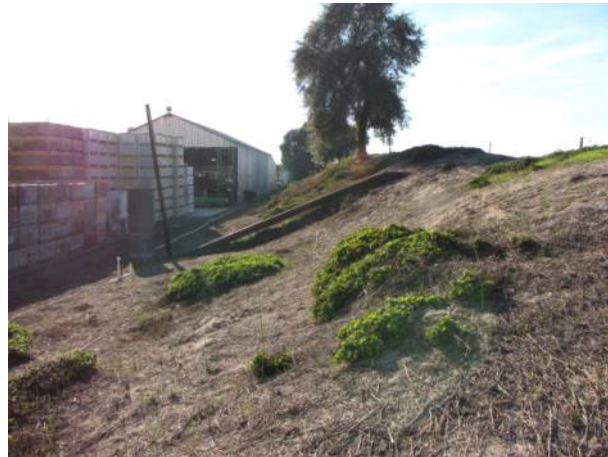
Levee Mile Report Line	5
Start Levee Mile	0.19
End Levee Mile	0.19
Location	Land Side
Category	Earthen Levee
Item	Vegetation

RD 755, looking downstream from landside toe. Photo taken 11-06-2012.
